The Northwest Tropical Atlantic Station (NTAS): NTAS-4 Mooring Turnaround Cruise Report

Technical Report

WHOI-2006-09

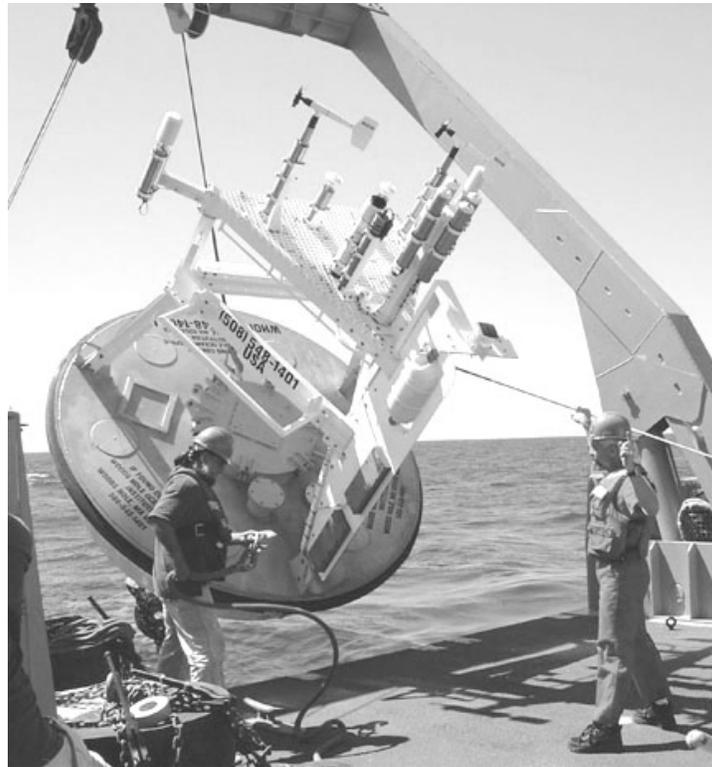
Figure 7. NTAS-3 buoy being lifted through the A-Frame (Photo by Wade Blake).

hailed in, eventually causing the lifting bale to rotate towards the stern of the ship. The buoy was then lifted until the hull was about 1 m above the transom (Fig. 7), the A-frame was moved inboard, and tag lines were attached. With the buoy stabilized, the A-frame was shifted fully inboard and the buoy was lowered to the deck. The mooring line was disconnected from the buoy bridle and stopped-off, after which the buoy was shifted forward with the ship's crane and secured. The TSE winch line was attached to the mooring line and the mooring chain, instrumentation and wire rope were hauled in using the winch.

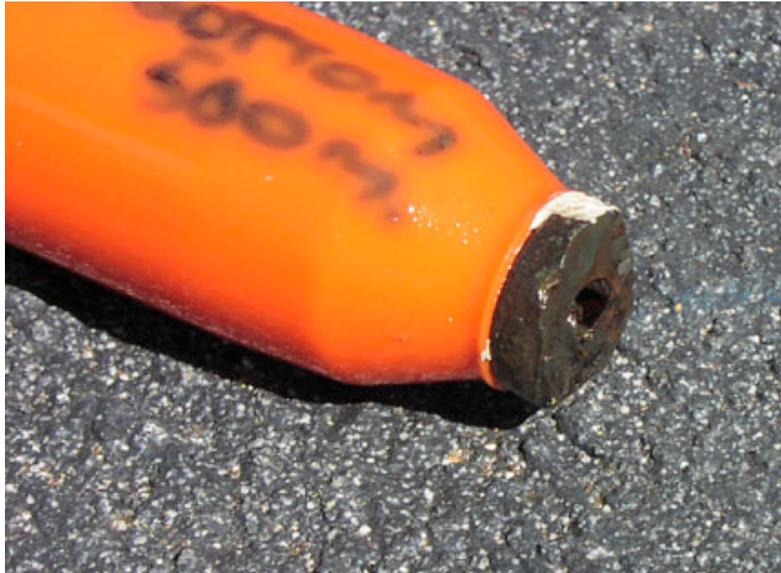
At the start of the mooring line recovery, it was unknown how much mooring material remained below the buoy. The uppermost instruments could be seen below the waterline, and the line was hanging nearly vertical, suggesting substantial weight below. In fact, the upper 600 m of the mooring, including all of the subsurface instrumentation, were recovered intact. The break in the mooring was found at the termination on the lower end of the first 500 m section of wire rope. The swage socket was fractured at the “shoulder” section, between the shank and the eye (Fig. 8).

The failed swage fitting was returned to WHOI for evaluation. Initial evaluation by WHOI engineers indicated a fatigue failure: The failure surface was smooth and contained a series of rings with increasing radius (“beach marks”). The fitting was then sent to the manufacturer, Crosby Inc., for further evaluation. Crosby’s report (Appendix 5) confirmed a fatigue failure, with a fracture initiated on one side below the eye and

propagating perpendicular to the plane of the eye. The beach marks indicated that the swage was subject to high-cycle, low-stress loading, as would be expected on a mooring with many wave cycles and most of the load carried longitudinally along the mooring line. There was no evidence of forging defects or improper swaging. The Crosby analysis suggested that the swage socket had been subjected to side-loading, which initiated the fracture.

Figure 8. NTAS-3 swage failure. The boot and part of a swage fitting at the lower end of the first 500 m length of wire is shown.

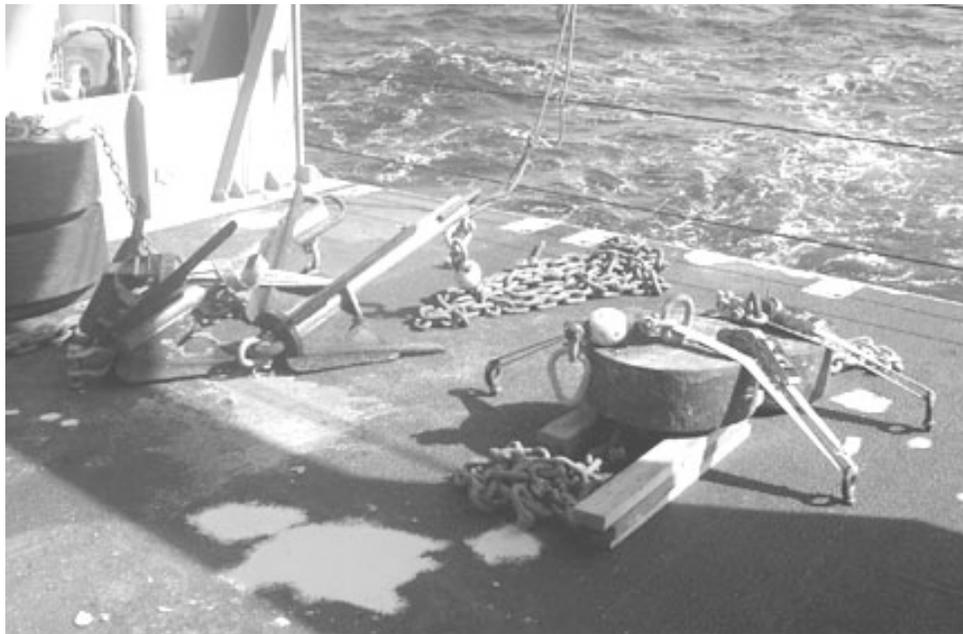
Figure 10. Dragging gear laid out on the fantail of the *Brown*.

the leader, intended to hook the mooring line as the leader was dragged along the bottom. The depressor weights and hooks, prior to attachment to the wire, are shown in Fig. 10. The intention was to lay out 850 m of wire on the bottom prior to haul-back (Fig. 9-2). The UOP 12 kHz pinger was attached at 700 m above the upper depressor weight. This was intended to allow the altitude of the wire to be determined at the location of the pinger, and to ensure that the desired length of wire was in fact laid out along the bottom (i.e. when the pinger was at 100 m altitude). Unfortunately, it was not possible to track the pinger with the ship's echosounder, so instead wire was laid out until the signal from the pinger indicated that it was on its side.

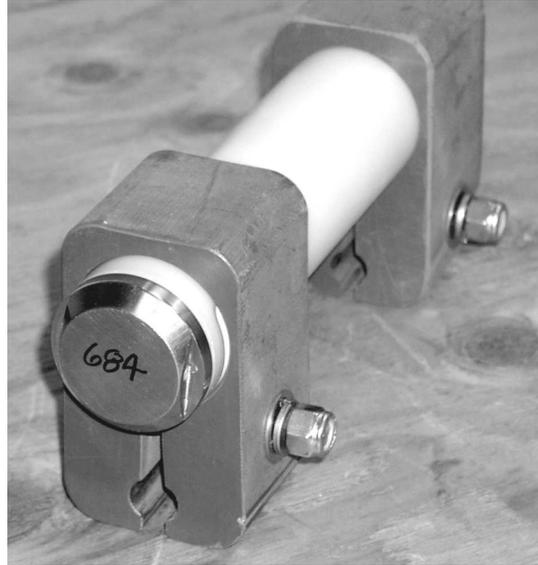
Figure 22. SBE-39 mounded in a wire clamp. No anti-fouling paint was applied.

Ten Sea-Bird SBE-39s temperature sensors were attached to the mooring line using two different techniques. In the upper 50 m, where chain sections were used, seven instruments were clamped to titanium load bars (Fig. 21) and the load bars were then attached in-line using shackles and pear rings. The instrument spacing was 5 m in the upper 20 m, increasing to 10 m spacing below. Between 60 and 80 m three instruments were clamped directly to the wire using specially designed clamps (Fig. 22). These instruments had 10 m spacing. The instruments were power limited, with a minimum sample interval of 5 min for a one-year deployment.

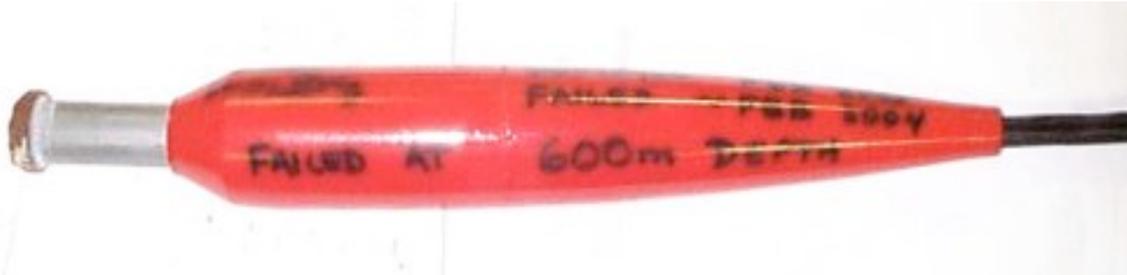
Figure 1. Photograph of the swage socket shank, wire rope, and jacket as it was received by the Laboratory.

(1) Visual/Macroscopic Examination: The returned swage socket consisted of the shank section still contained on a piece of covered wire rope with a special jacket (Enclosure A, Figures 1 and 2). The eye section of the socket was not returned. The fracture had occurred in the section below the eye and approximately 3/8 of an inch above the shoulder where the shank section terminates. The fracture surface was corroded and did contain evidence of fatigue (Enclosure B). The observed beach marks on the fracture surface had progressed through more than 1/2 of the cross sectional area before the final fracture occurred. The fracture had initiated on one side below the eye and propagated perpendicular to the plane of the eye. There were no legible markings observed on the returned section of the socket. The shank section was not corroded and still contained the galvanize coating. A measurement taken on the outside diameter revealed that it had been swaged to the specified catalog maximum dimension for a 1/2 inch socket.

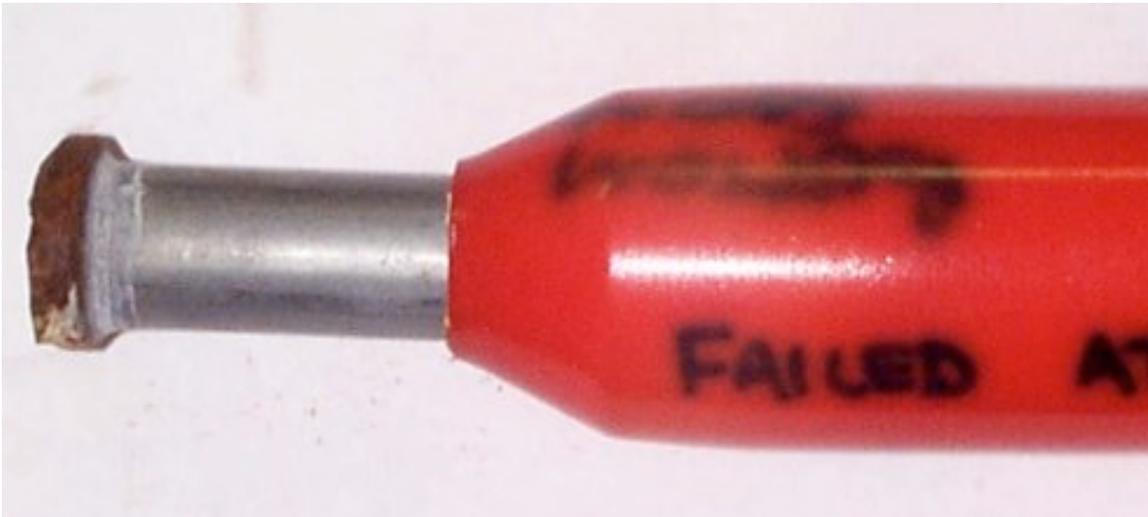
Figure 2. Photograph showing the shank section of the fractured swage socket.

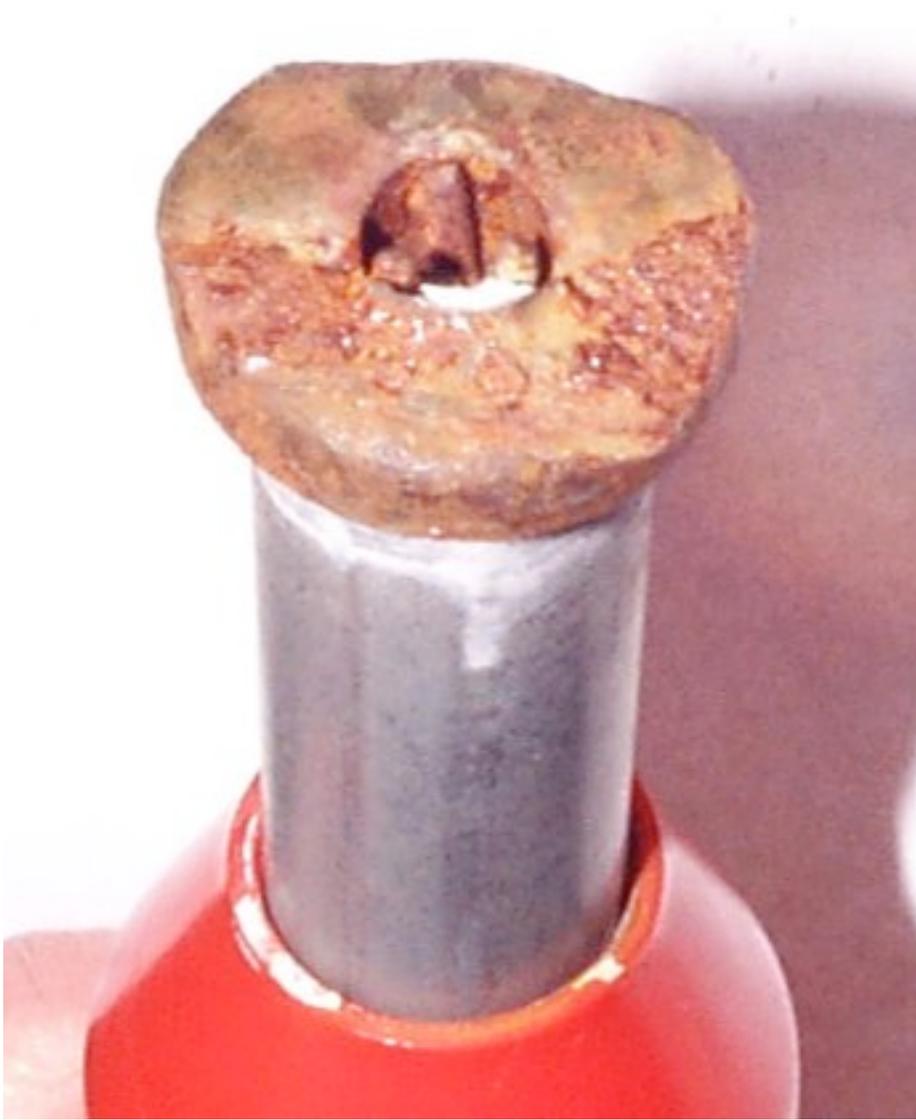
Photograph showing the fracture surface from the returned ½ inch swage socket.

Discussion: The analyses performed on the shank section from the fractured socket revealed that it had been forged from the specified steel type and had been properly heat treated. The fracture surface from the socket contained evidence of a fatigue fracture. The beach marks indicated that the final fracture had occurred when there was less than ½ of the original cross section remaining. It appears, based on the beach marks, that the socket had been subject to a high cycle, low stress loading condition. The location of the fracture also appears to indicate that the socket was subjected to some side loading, possibly from restraint in a clevis attachment. The eye section of the socket was not returned. The pertinent markings are located on the eye section of the socket. Without a product identification code, the age of the socket could not be determined.
